Thompsonville Fire Department

**Thompsonville Fire Department
11 Pearl Street
Enfield, Connecticut 06082-3501
Phone: 860-745-3365 Fax - 860-745-1492
Connecticut State Fire Safety Code
Abatement Order of Fire/Life Safety Hazards**

Thompsonville Fire Department The Site

Thompsonville Fire Department The Facility

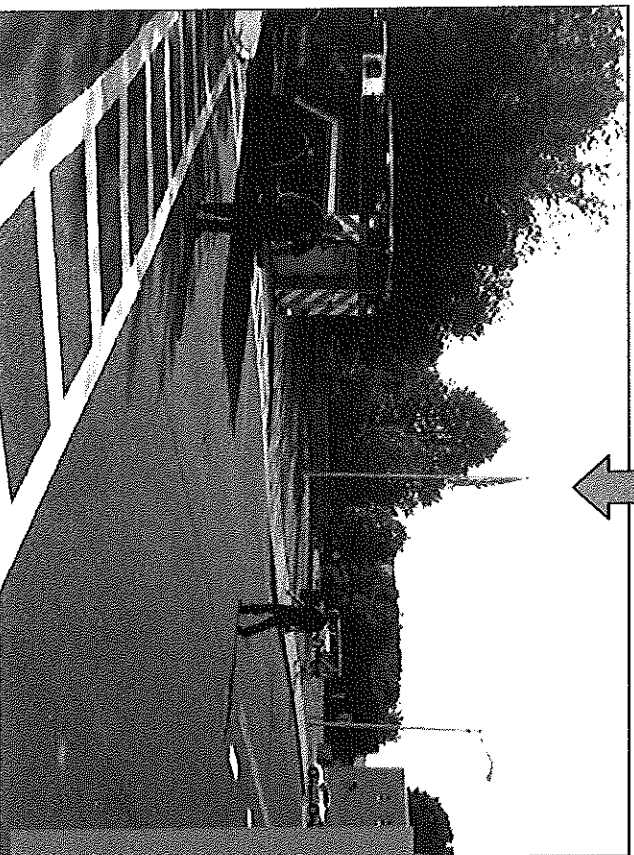
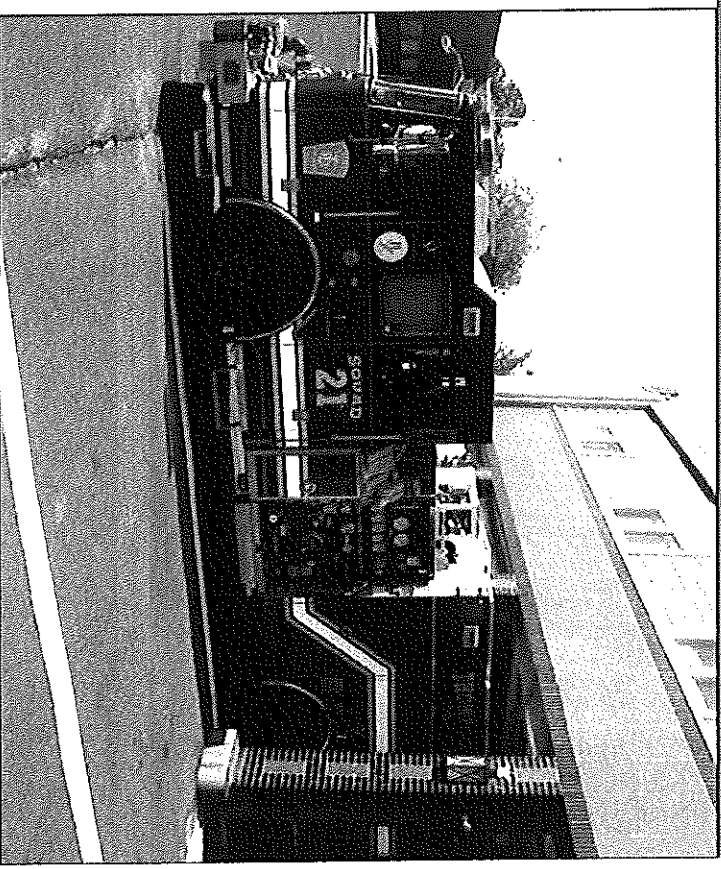
Apron is too small and inherently unsafe.

Impediment to pedestrians and vehicles

Apparatus must use road as turn-around space.

Non-conformance with FEMA FA-168

- 60' apron required, or 15' more than longest anticipated apparatus
- Turn around area out of public way

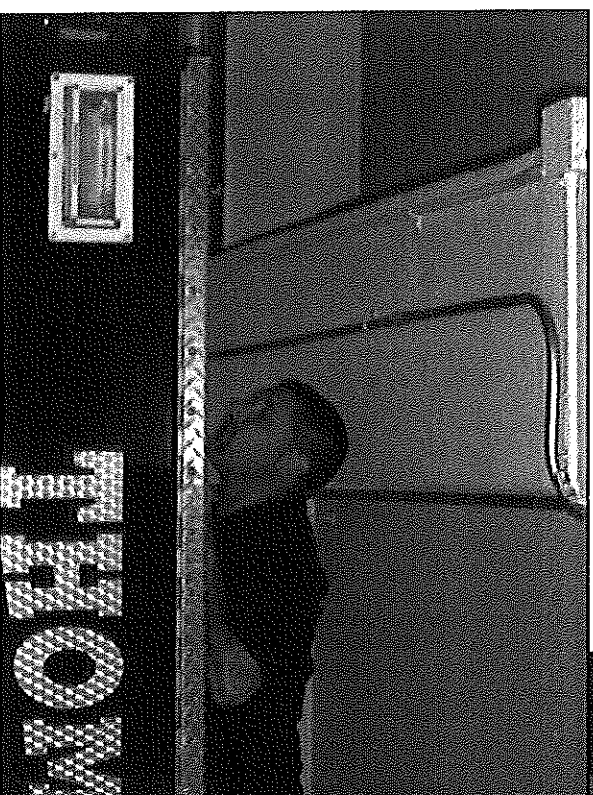
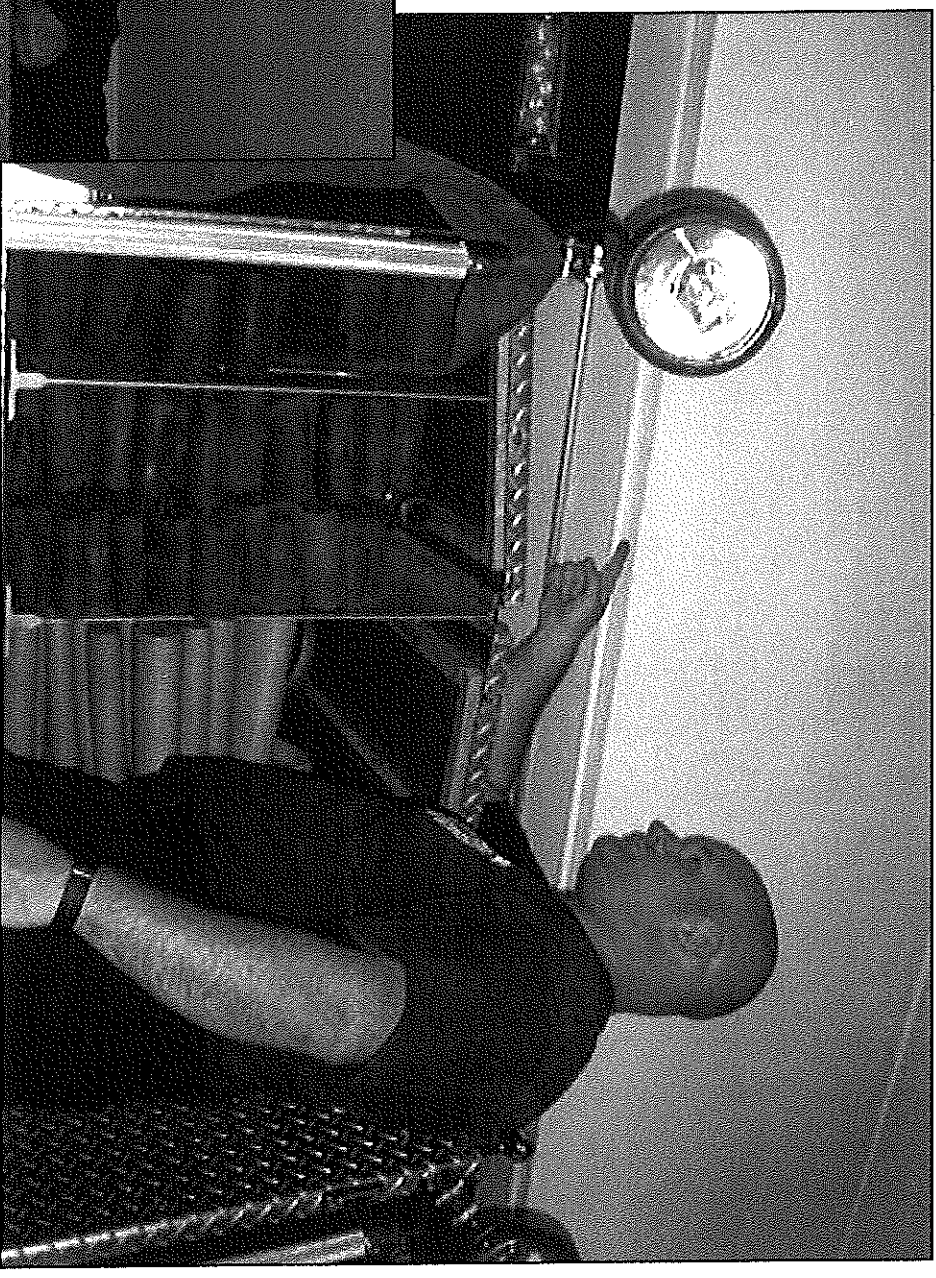
Ceiling heights are too low to allow access to truck compartments.

Non-conformance with functional
requirements of apparatus

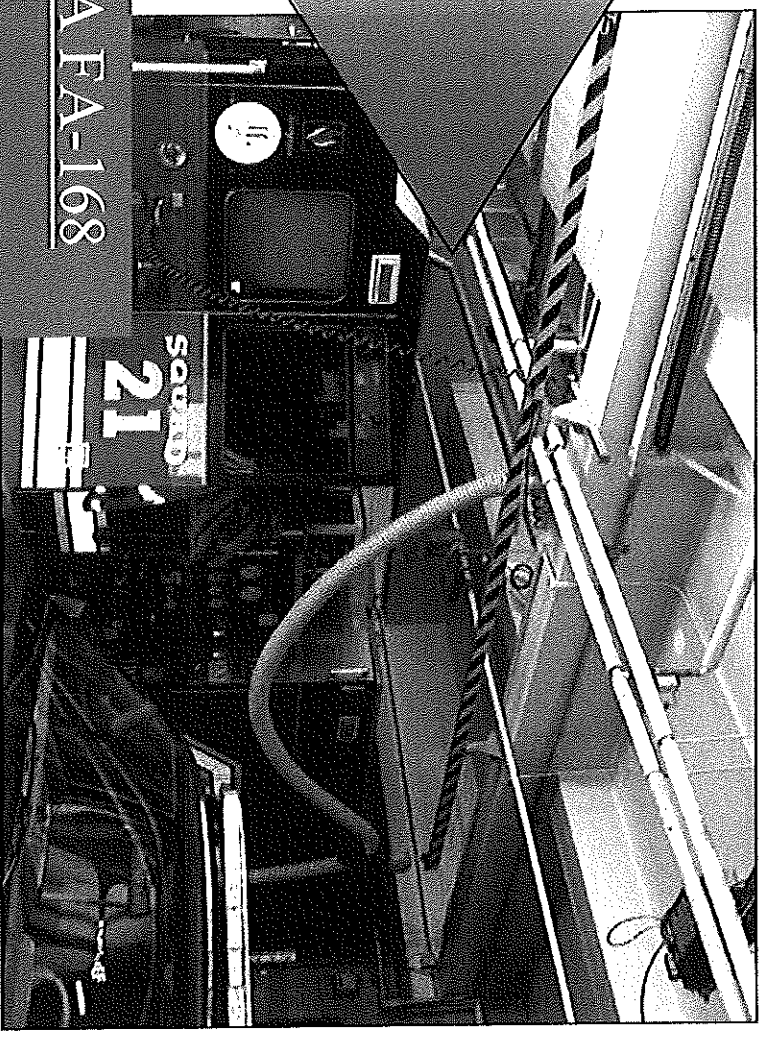
No room to tip up cab, tight quarters between vehicles.

Non-conformance with FEMA FA-168

- 3' clearance required around all apparatus parked in station
- FEMA Example: 1940's design cannot accommodate current apparatus dimensions

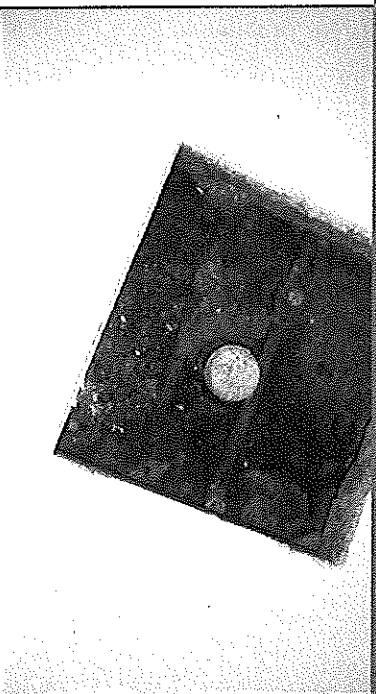
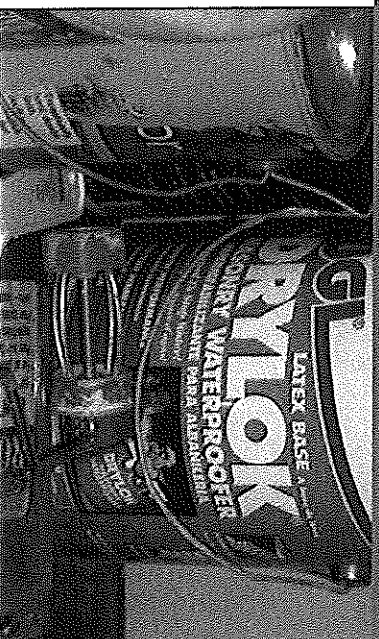
In addition to moisture in basement, there have been significant floods. Most recently in 2003: 3' – 4' of water in the basement. In 1955 floodwaters rose to the first floor.

Non-conformance with FEMA FA-168 and IBC

- History of flooding
- Relocation must be considered
- Upgraded structures are required in flood-prone areas

Repairs and other stop-gap measures cannot solve the problem.

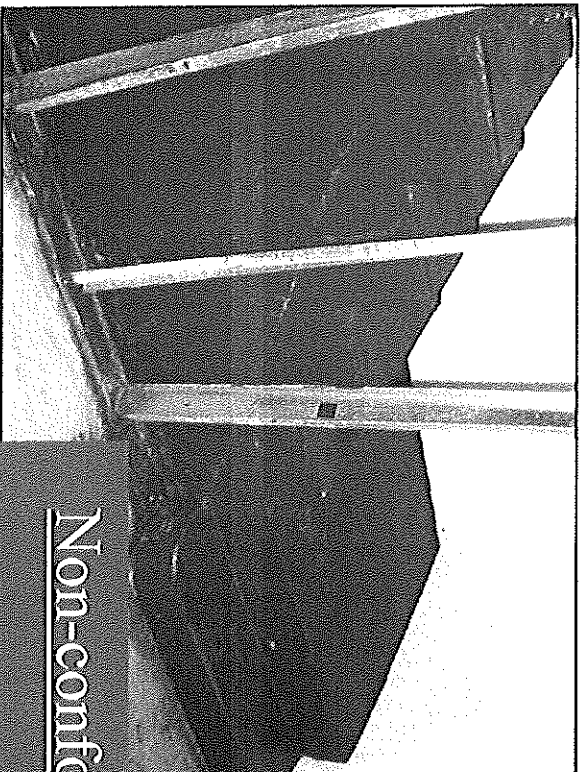
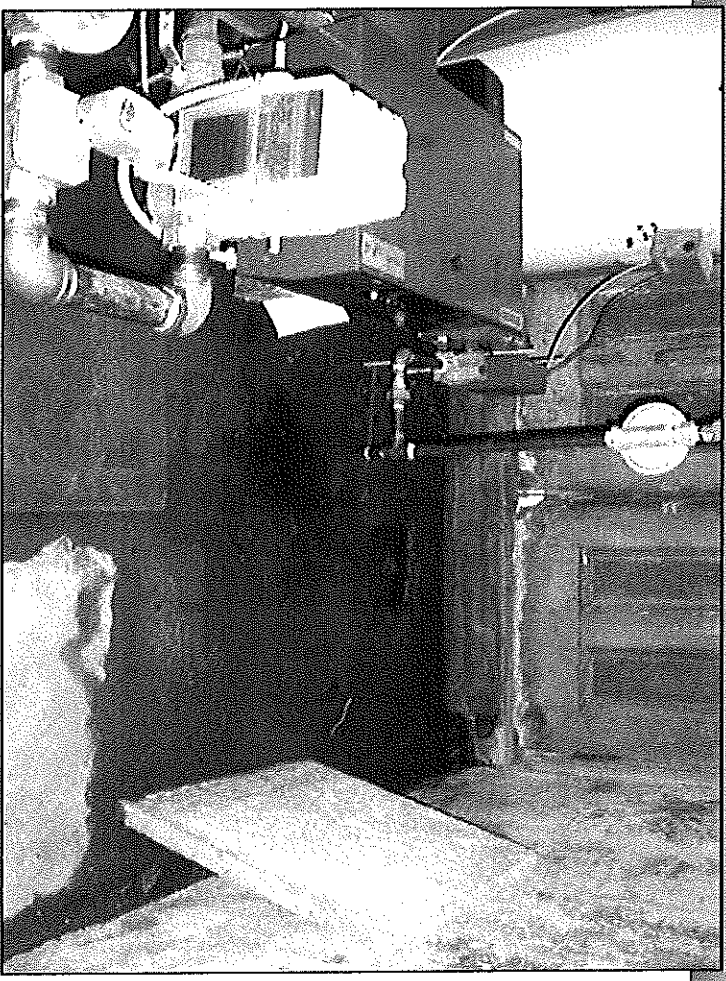
Moisture intrusion is
a constant problem
365 days/ year.

Non-conformance with FEMA FA-168 and OSHA

- Flood prone areas should be avoided
- Sick-building syndrome
- Water on floor areas is hazard for slipping

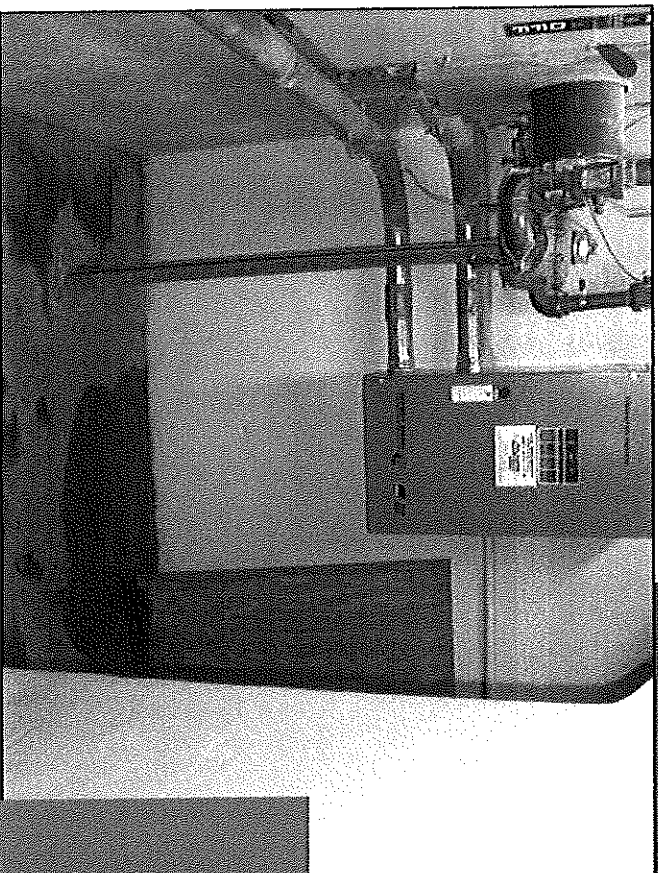
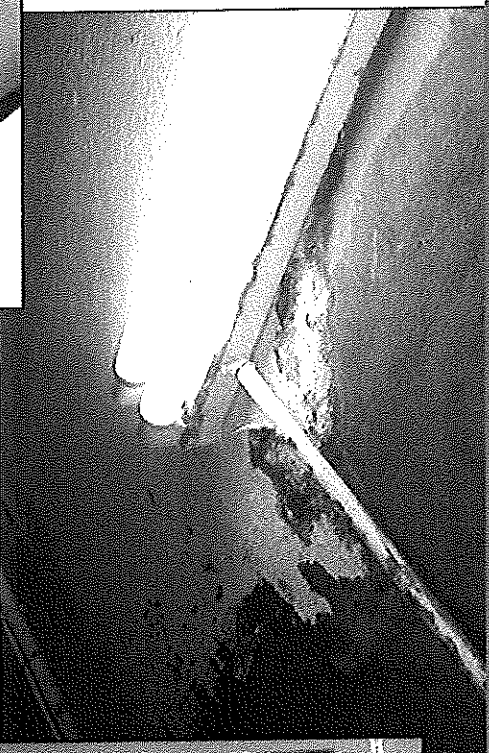
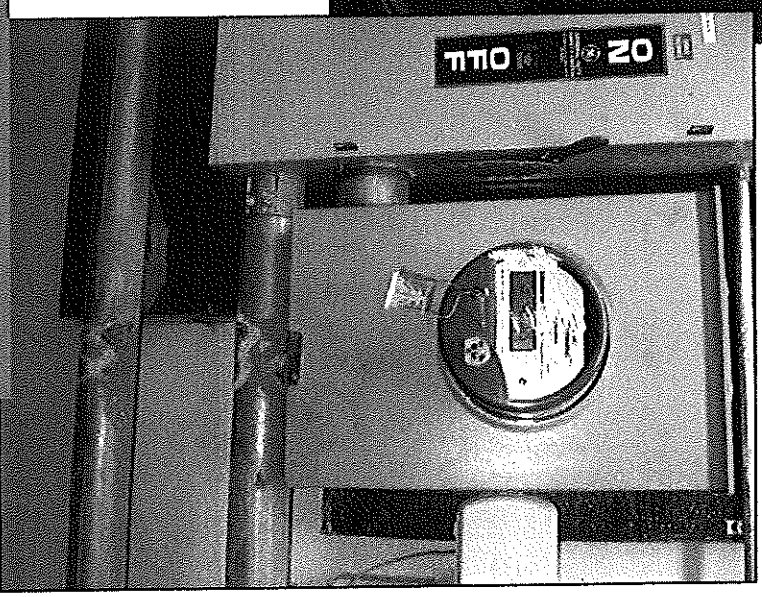
Water runs through
electrical service and
fixtures.

Non-conformance with NEC

- Electrocution hazard
- Disruption of service

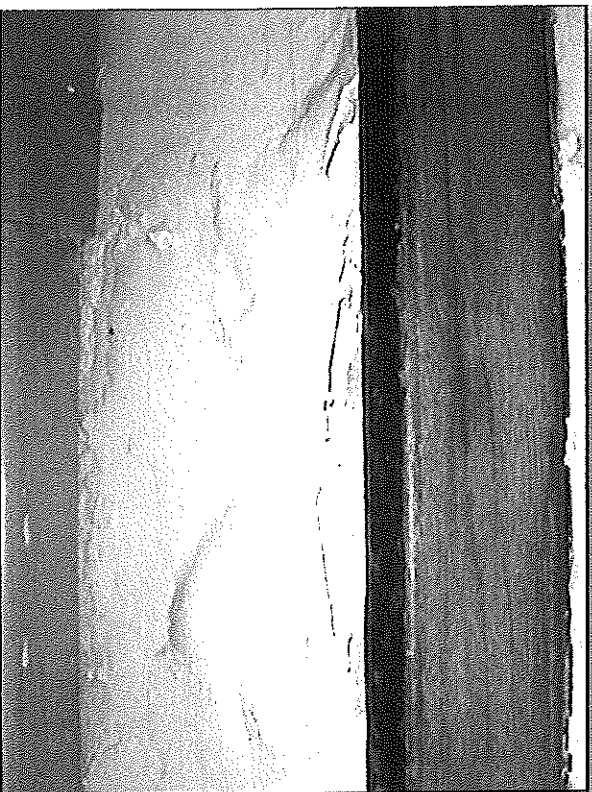
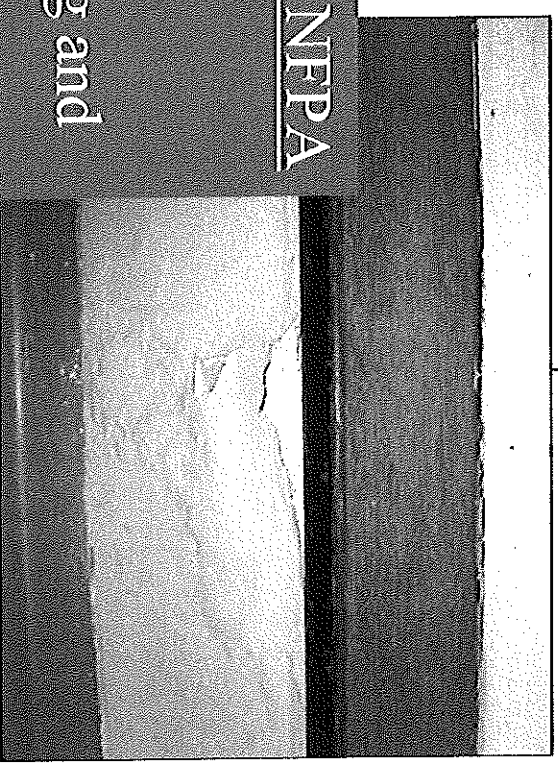
Despite numerous and frequent repairs, moisture penetration in walls continues.

Non-conformance with FEMA FA-168 and NFPA

- Sick Building Syndrome
- Proper heating and ventilation of sleeping and living areas

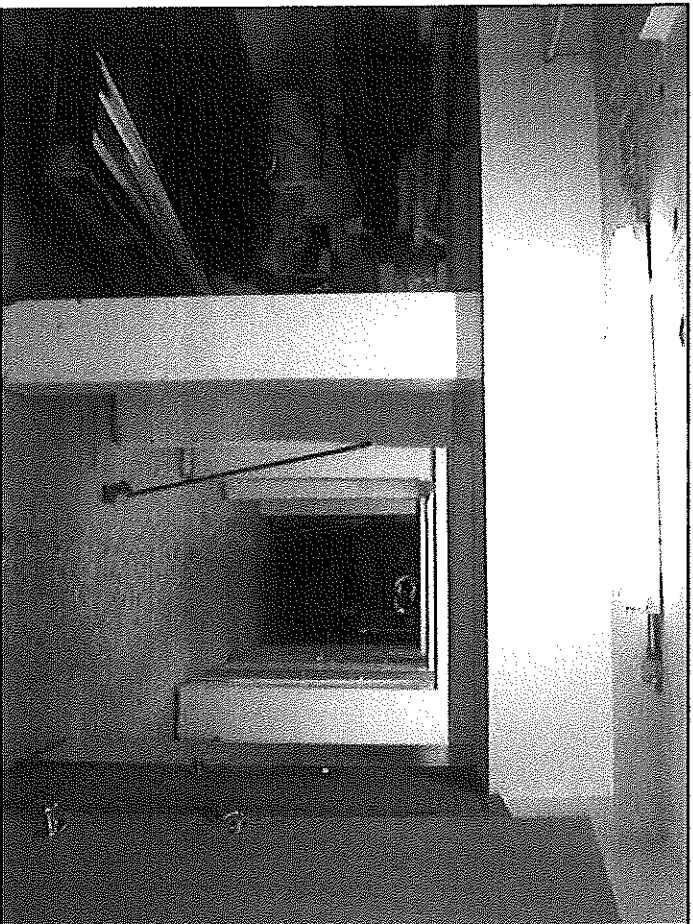
There has been an ongoing 20 year battle with structural slab failure.

Reports from 1987, 2001, 2007 and 2008

Structural repairs in 1988, 2001 and 2007

Conclusion from structural engineers – “The spalling that has occurred can be expected to happen again as moisture continues to rust the reinforcing steel... the concrete floor itself will need to be replaced”

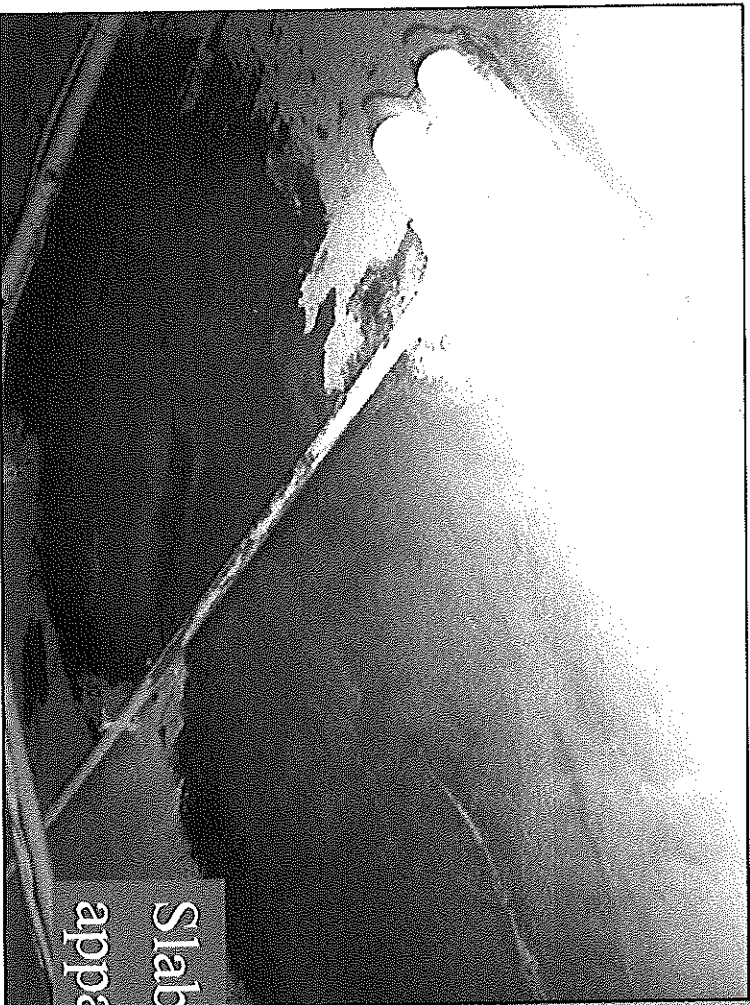
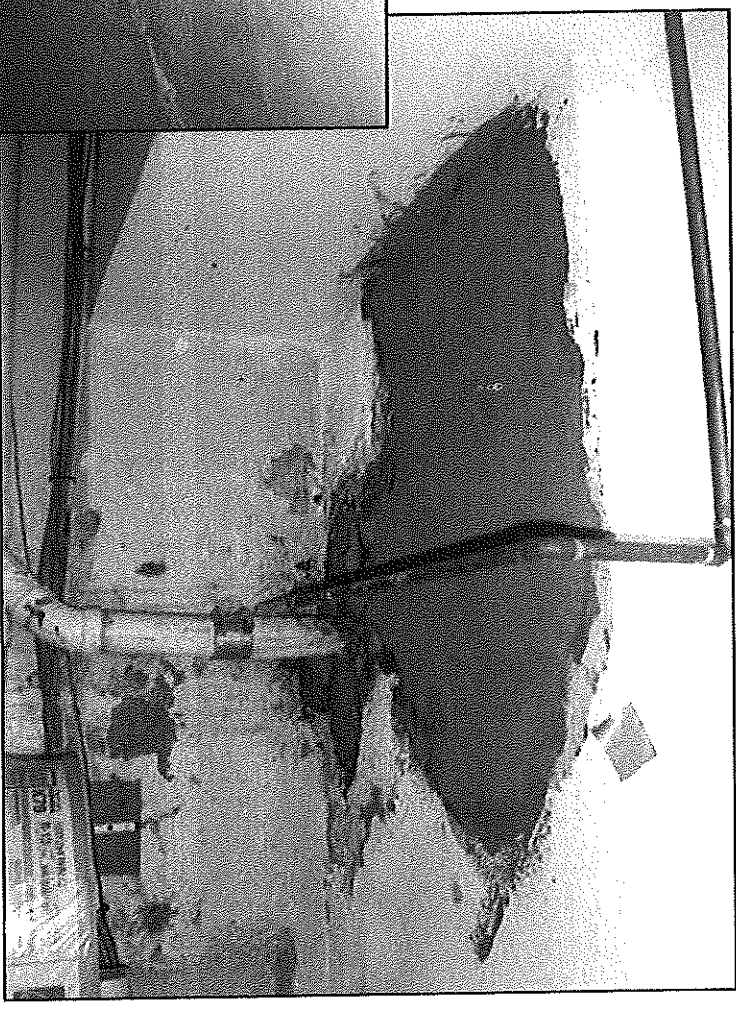
Structural failure

Slab was not designed for modern
apparatus or safety standards.

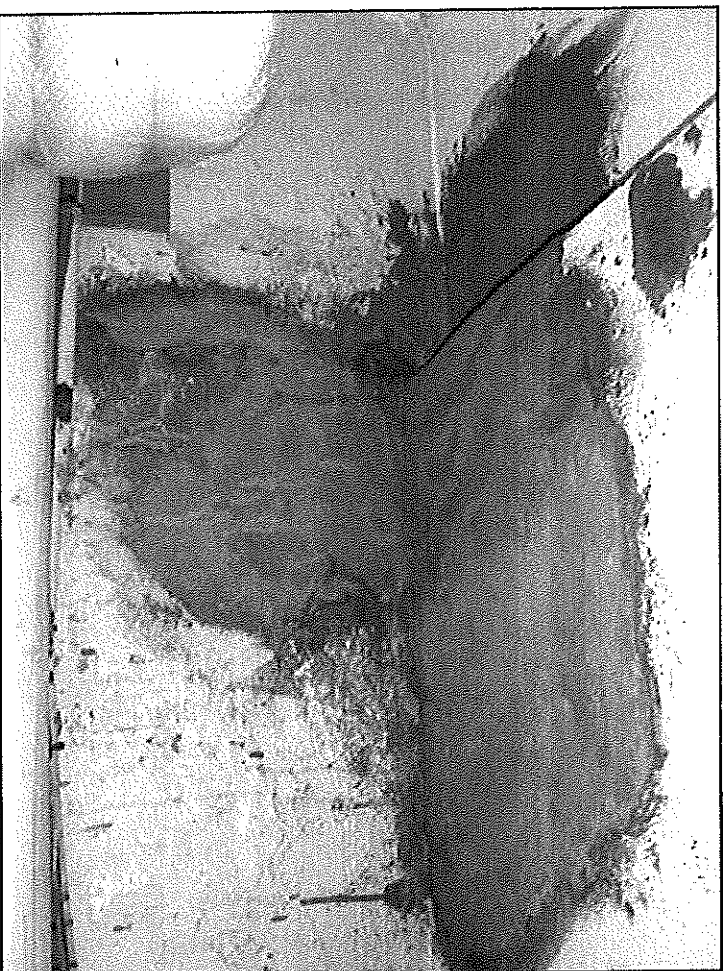
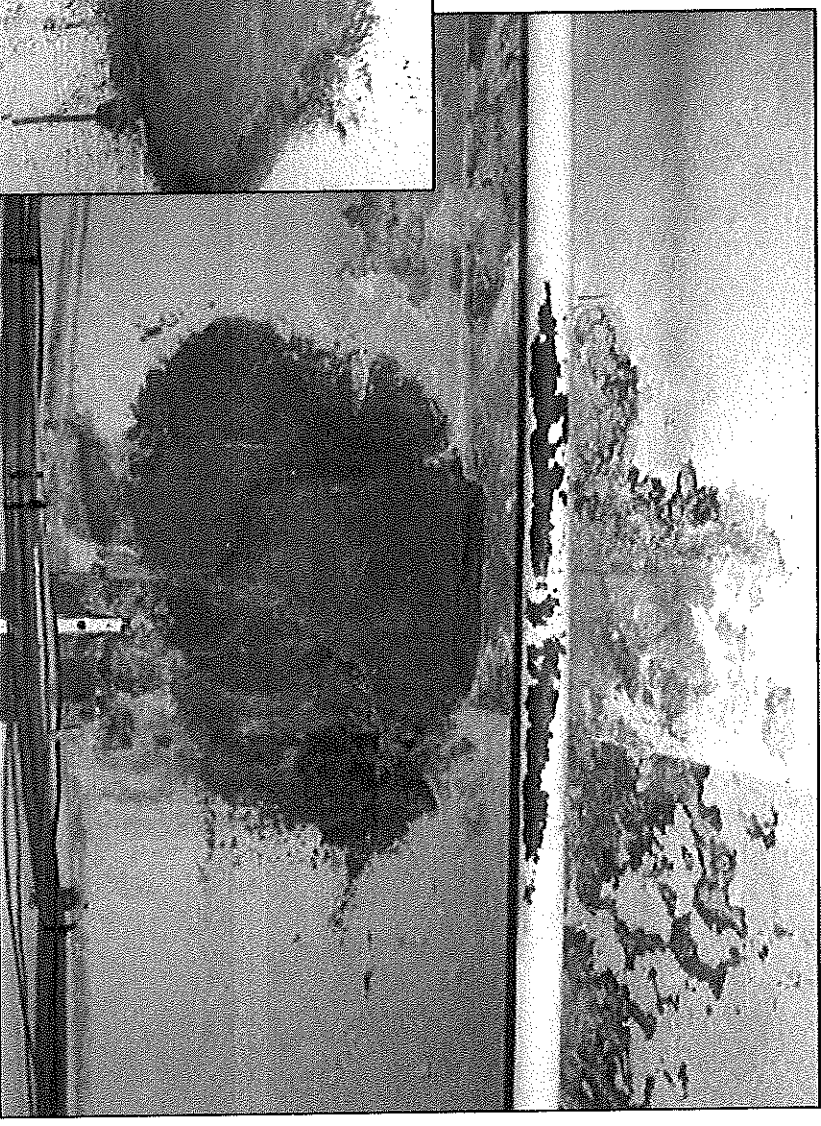
Structural failure

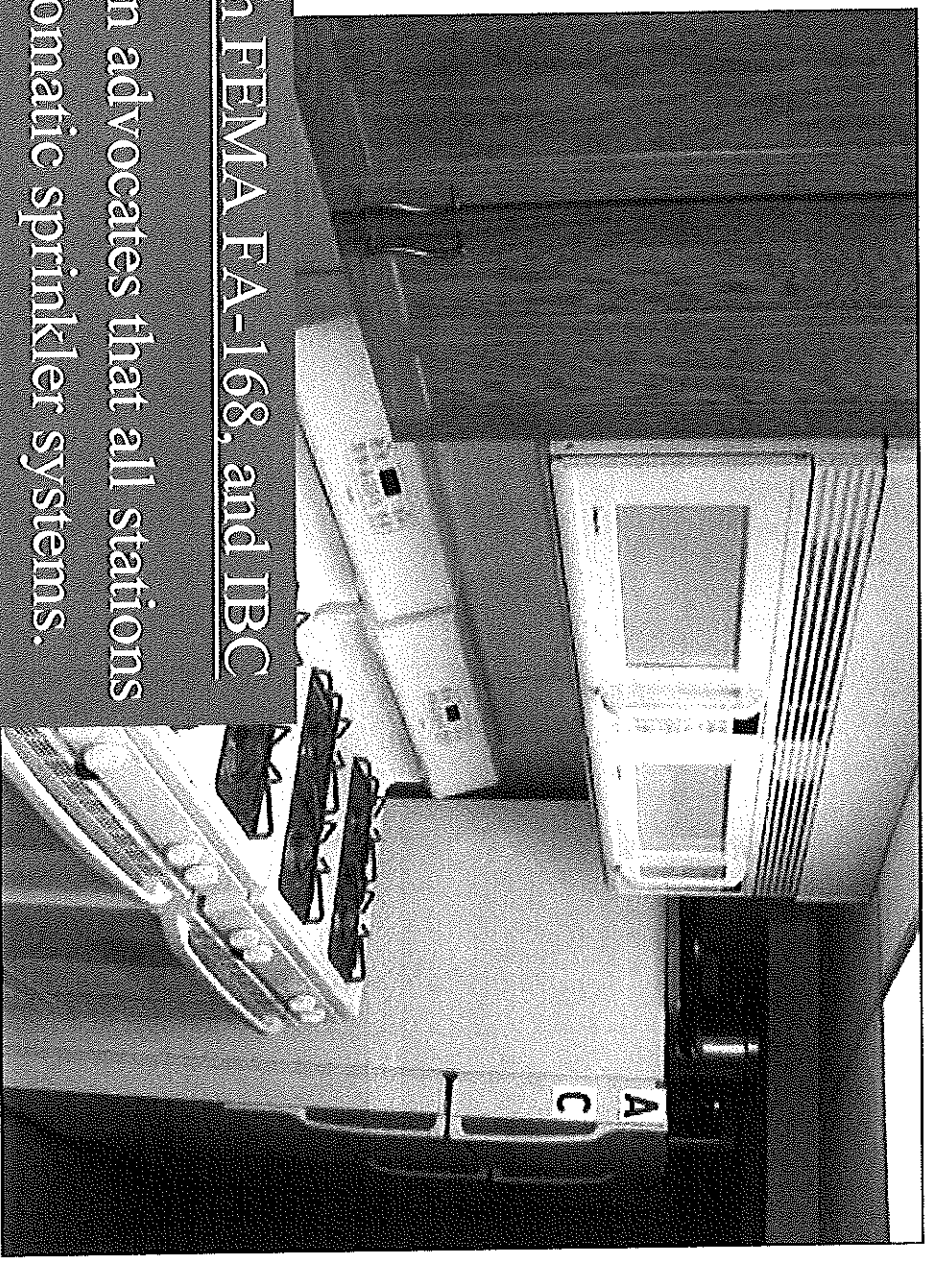
There is no Ansul system or building sprinkler system. The kitchen has already experienced a fire and was destroyed in the 2003 flood.

Non-conformance with FEMA FA-168, and IBC

- US Fire Administration advocates that all stations be equipped with automatic sprinkler systems.
- Ventilation and suppression hoods required at kitchen equipment

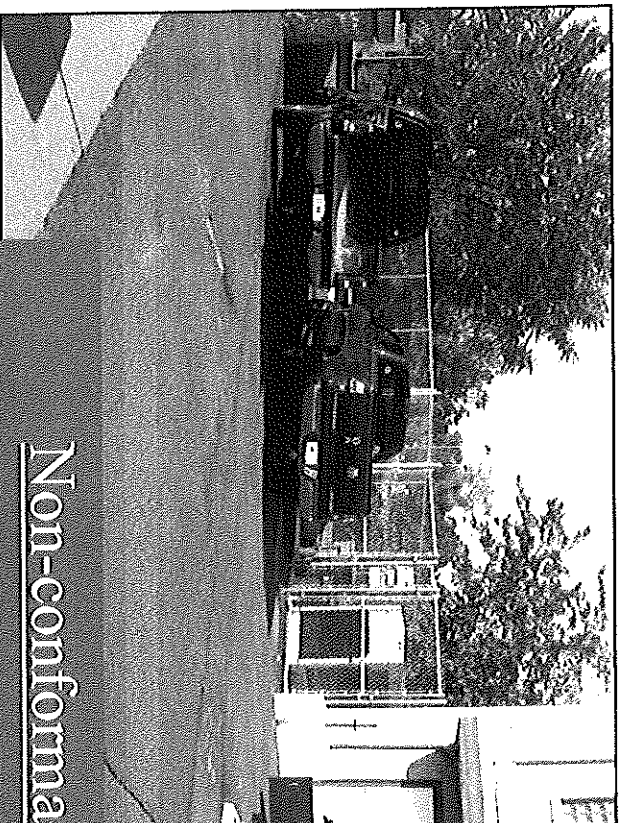
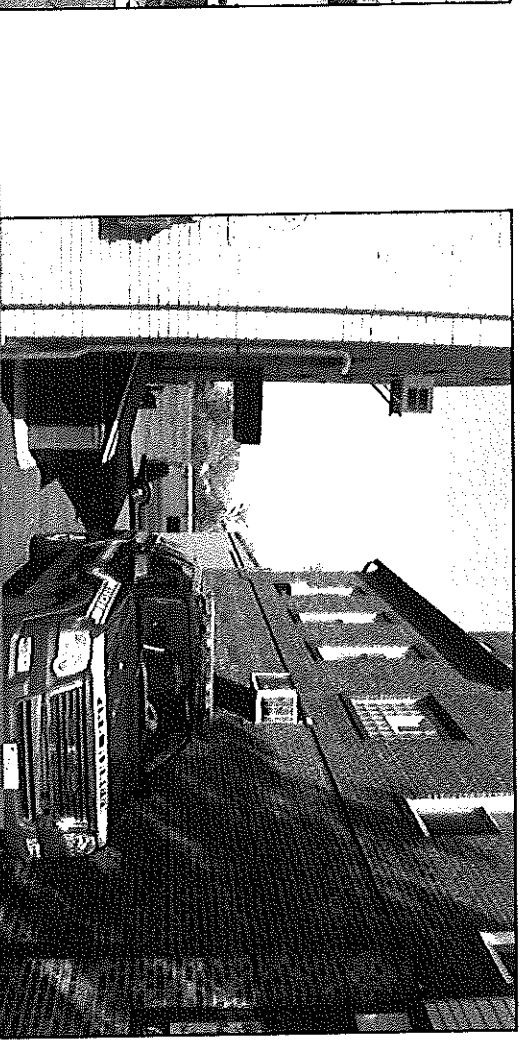
Inadequate parking

Non-conformance with FEMA FA 168

- Ample parking for personnel working at facility
- Requirement for adequate parking for personnel during shift changes
- Side yards should accommodate hose lays

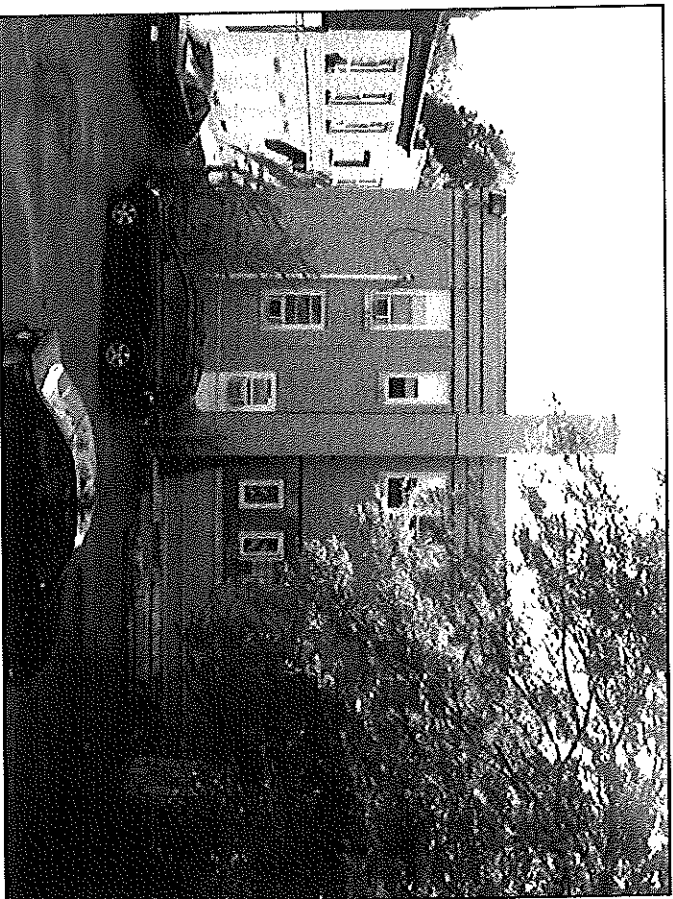
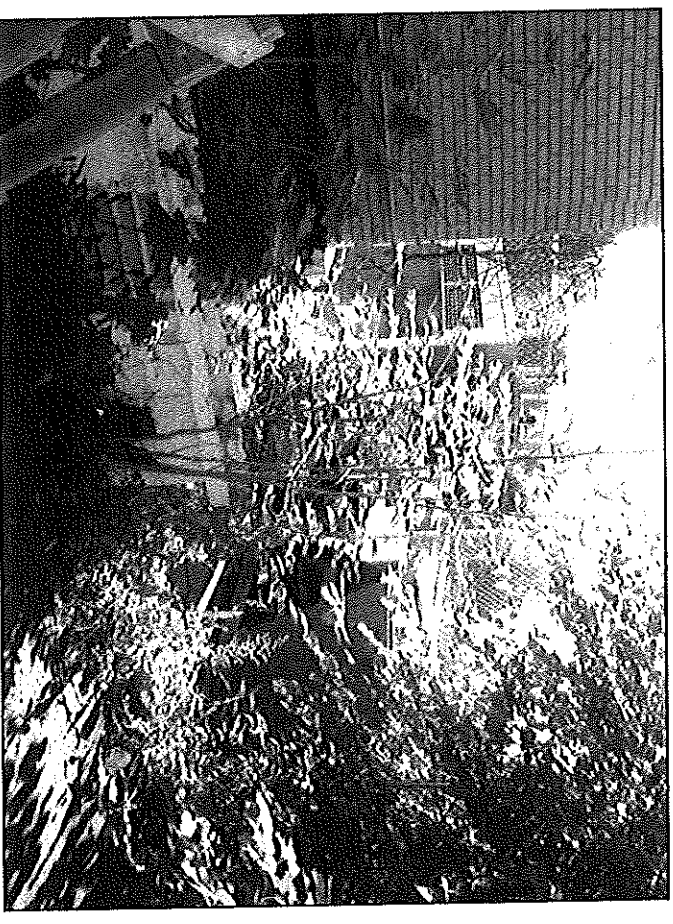
Lack of land for expansion

Non-conformance with FEMA FA-168

- Facilities should be flexible for future requirements
- Build for potential growth

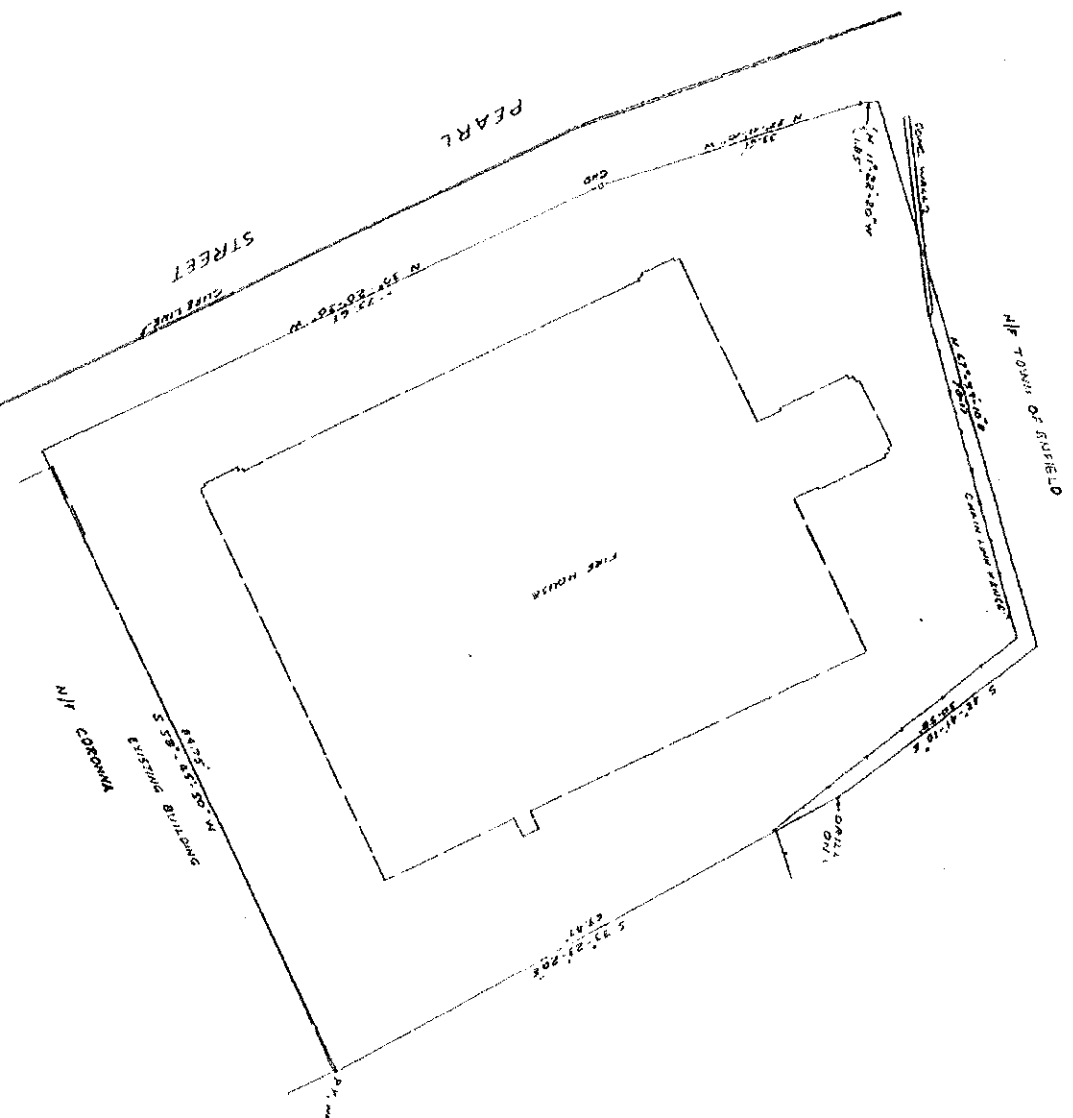
Existing Site Plan

- No room for expansion
- No room for operational requirements

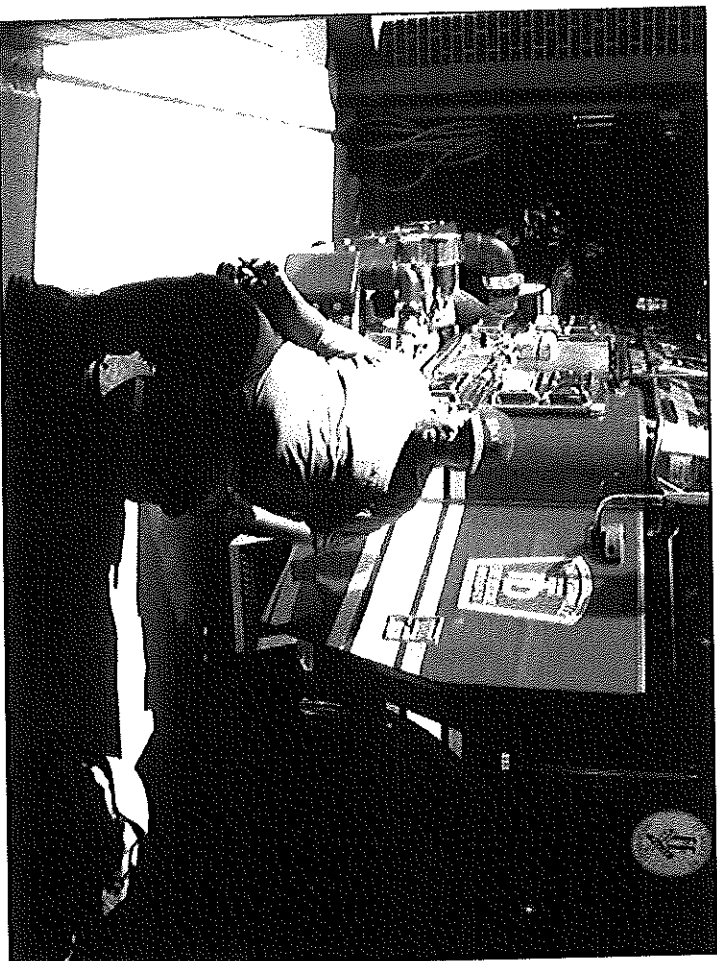
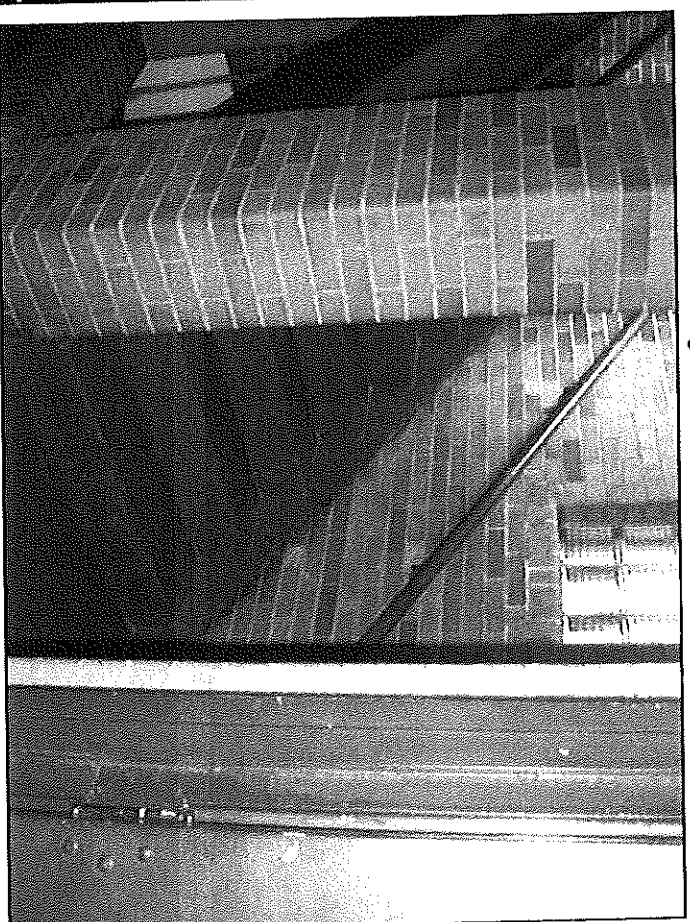
No handicapped accessibility

- Non-conformance with ADA, IEBC, FEMA FA-168, and IBC
- Access to Primary Function

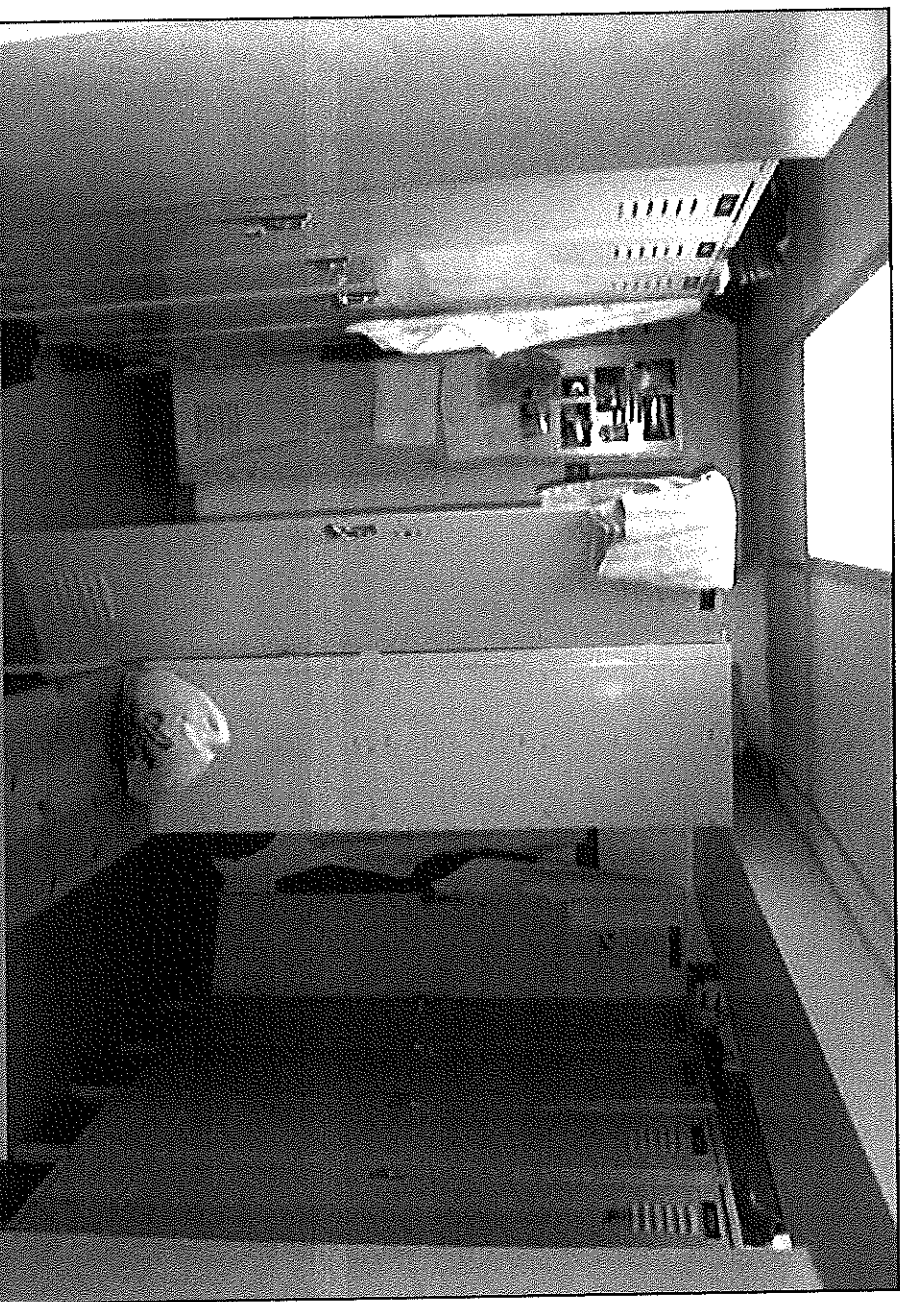
No gender separated
bunks/baths/lockers

Non-conformance with FEMA FA 168 and IBC

- Accommodation for female emergency responders

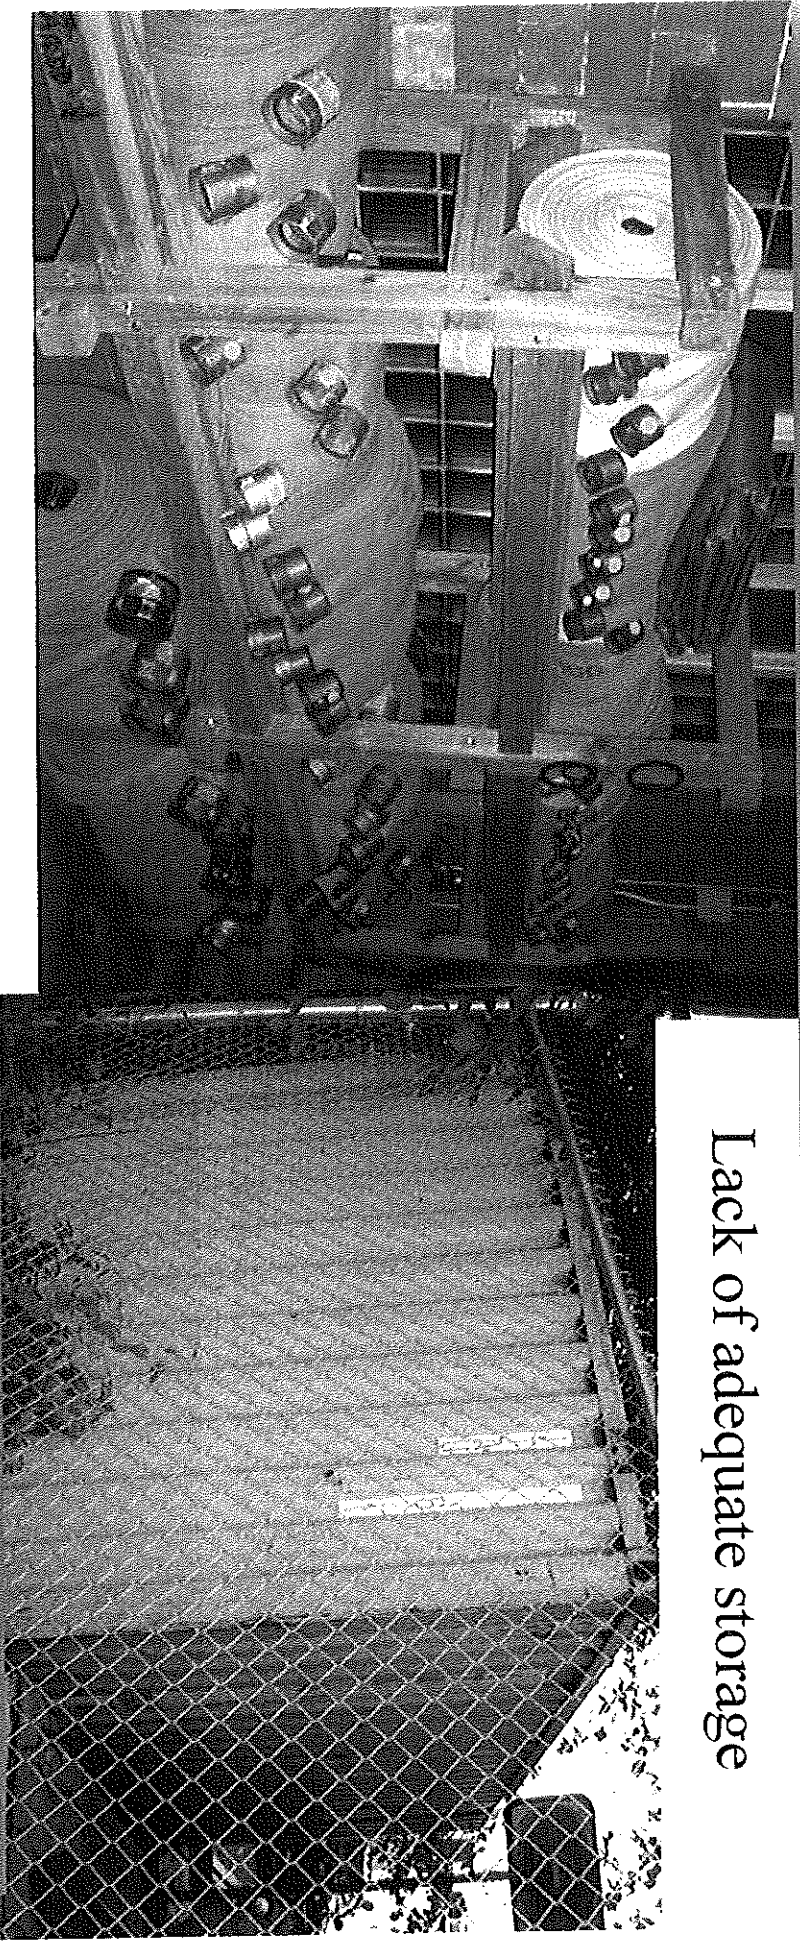
Lack of adequate storage

Non-conformance with NFPA 1581 and FEMA FA 168

- Adequate Storage for Equipment in dedicated rooms
- Future increased specialization and utility needs

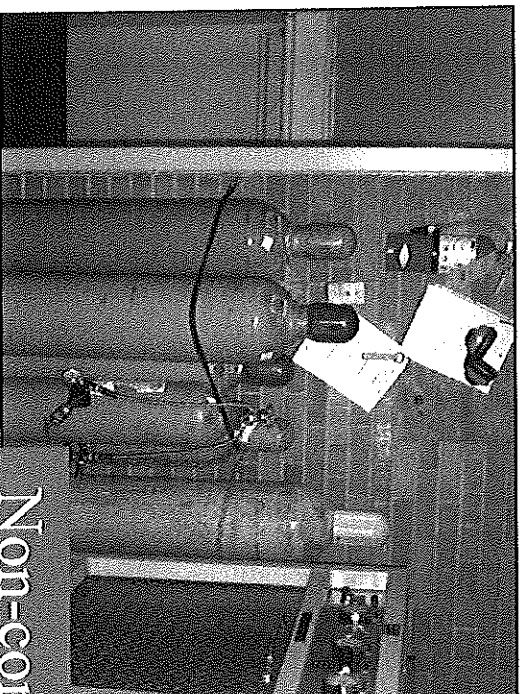
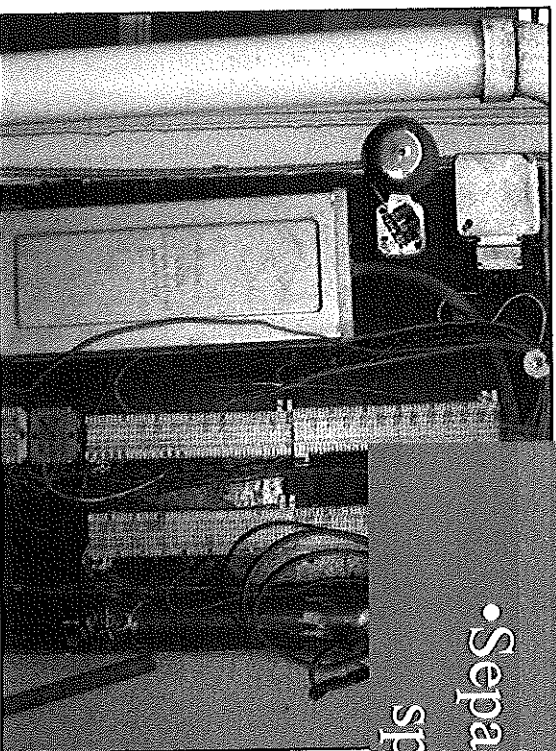
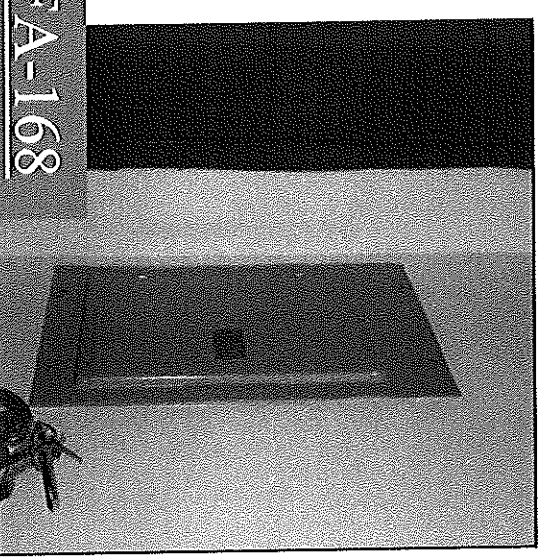
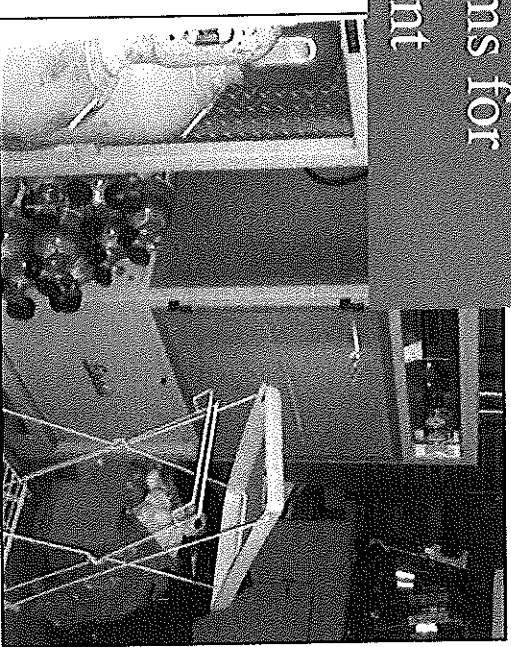
Lack of
specialized
rooms

Non-conformance with FEMA FA-168

- Separate dedicated rooms for specialized equipment
